WYOMING STATE CAPITOL REHABILITATION & RESTORATION

LEVEL I RECONNAISSANCE / LEVEL II FEASIBILITY STUDY

EXECUTIVE SUMMARY AND FREQUENTLY ASKED QUESTIONS

17 FEBRUARY 2014

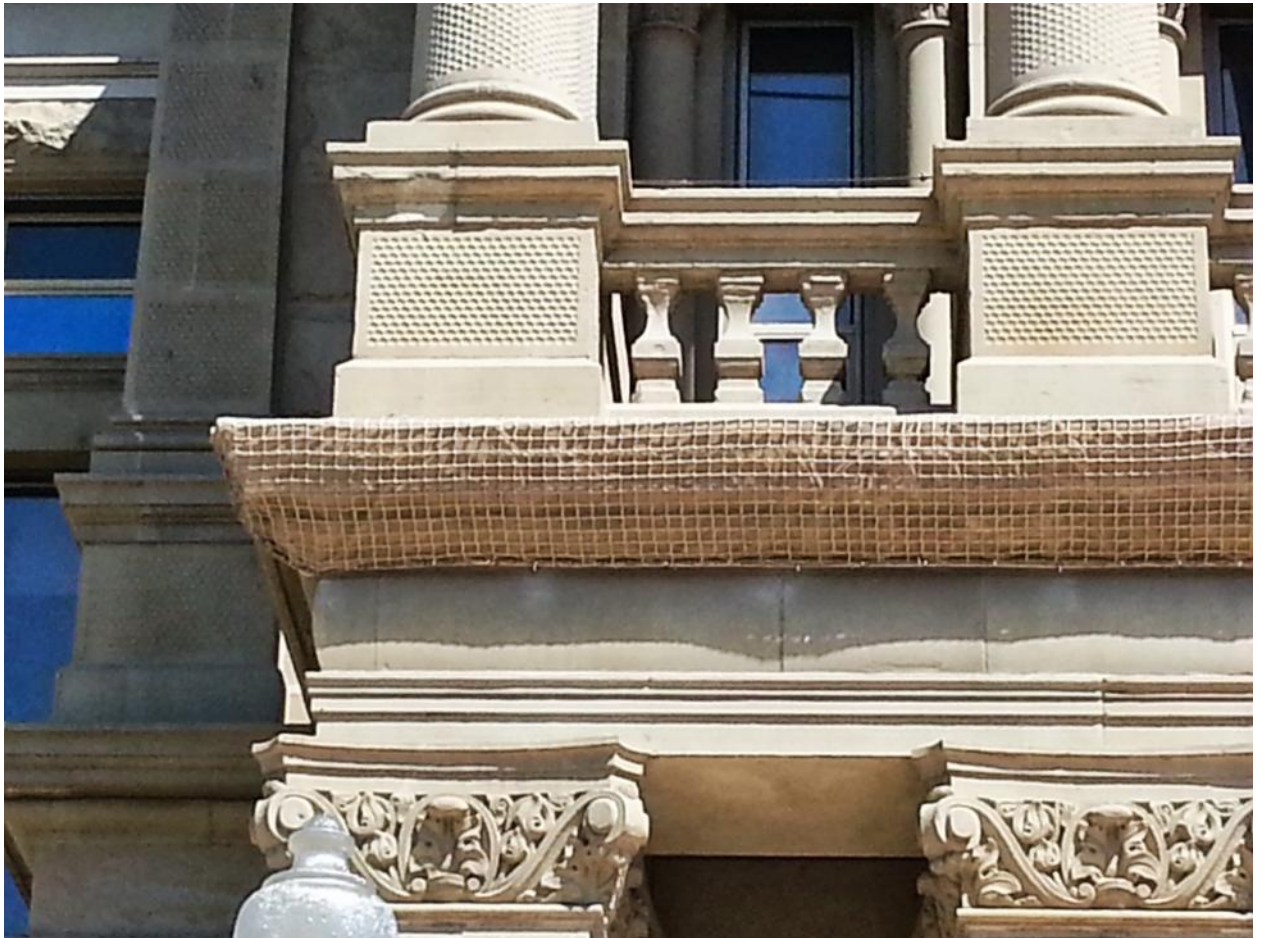
The Capitol itself has indications of strain and deterioration which warrant prompt attention.

- The stone on the Capitol exterior walls is generally sound, however significant localized issues exist.
 - In July of 2013, a stone over the front steps was found to be loose. A net was specified to stabilize the area; however, during installation of the net, a portion of the stone simply landed in the contractor's hands. Many stones need attention.
- The roof and dome are badly damaged from hail.
- The skylights are leaking over the stained glass and chambers.
- The dome appears to be generating cracks at the rotunda area through either rotation or some other issue.
- Other cracks appear to be associated with how the Herschler corridor connects to the Capitol.

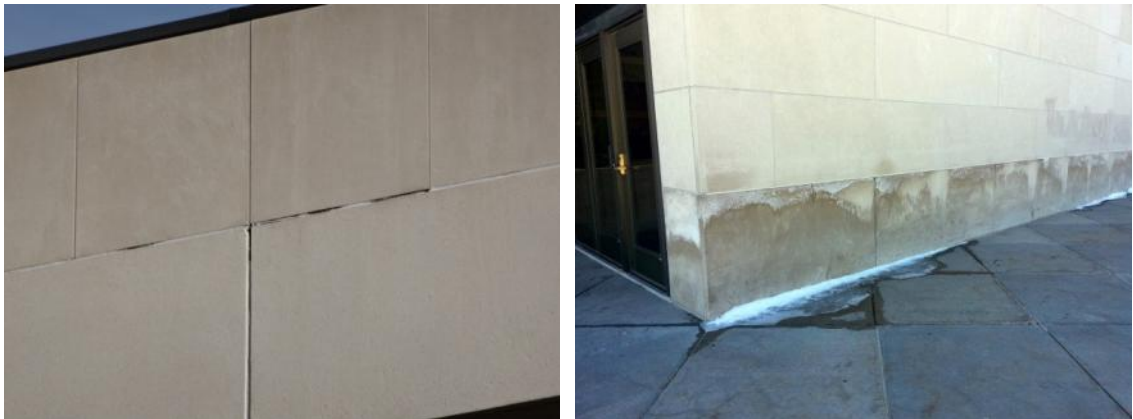
An additional concern with the Herschler building, that is being investigated further, is to understand the condition of the exterior walls. These walls have indications of leaks and require review to determine if these leaks are creating problems within the wall. Whereas this seems likely, the issue is open at this time.

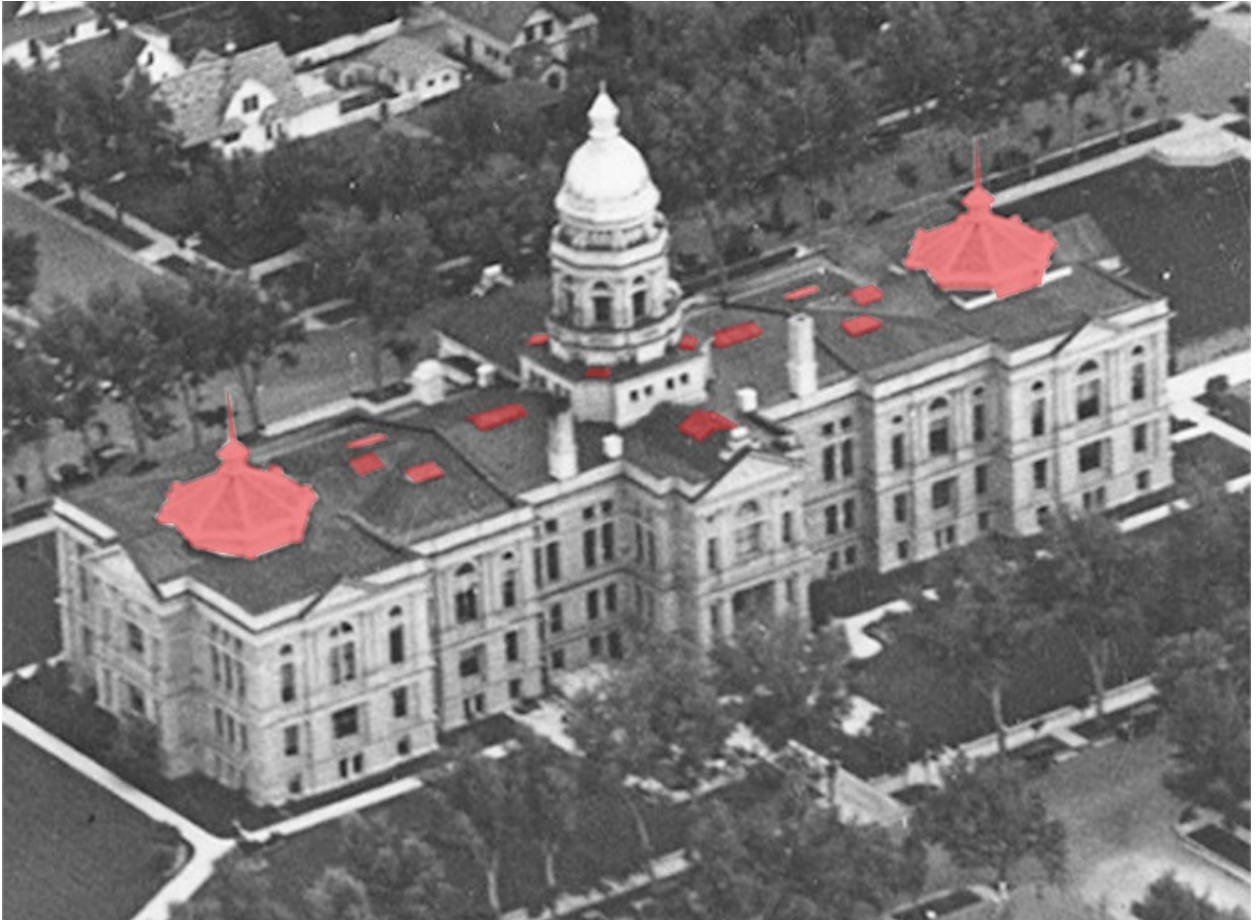
Figure 11.3: Aerial Photograph of the Capitol, ca. 1930. The Locations of the Skylights are Highlighted in Red.

- a. The original House and Senate Chamber Skylights [ornamental pyramidal roofs in aerial photo above] were replaced with a new skylight system. There are several active leaks along the edges of these skylights due to corrosion of the metal cladding.
- b. The existing standing seam metal roofs have widespread hail damage.
- c. The existing EPDM roof has numerous patches, and the maintenance staff states that they patch the roof on an annual basis. The EPDM roof is nearing the end of its useful life and will require replacement in the near future.

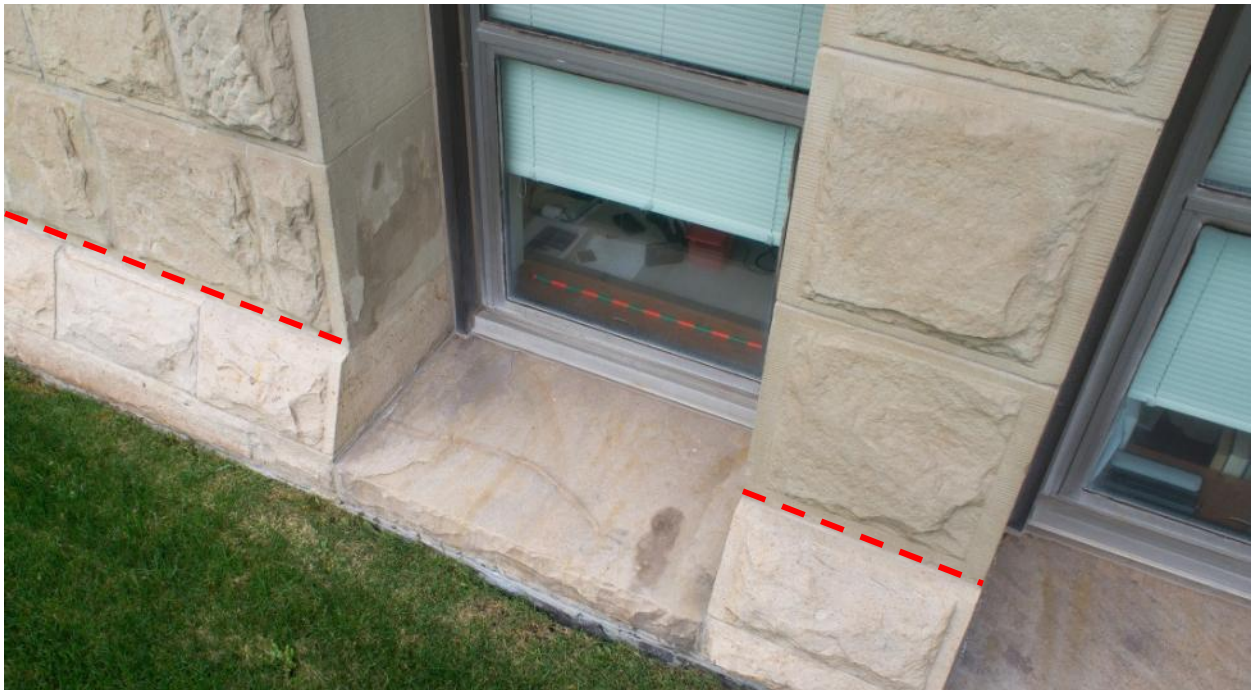
Figure 11.5: The Arrow Points to the First Two Courses of Sandstone, which is Buff/Pink Sandstone from Fort Collins, Colorado. The Remaining Sandstone is Quarried from Rawlins, Wyoming, 2013.

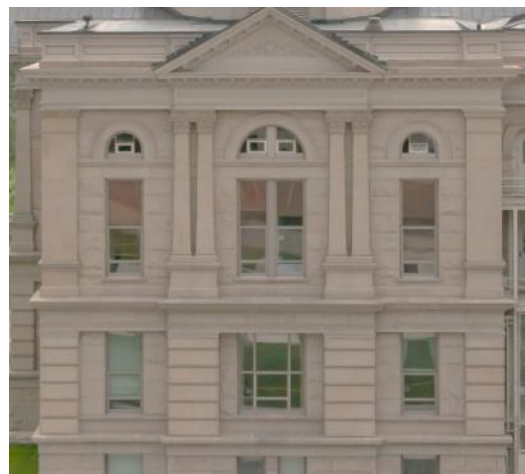
Figure 11.7: Existing North Elevation Windows.

The replacement program, a typical practice of the period, did not follow any of the best practices and preservation standards. Instead, commercial units were installed, that were significantly different in appearance and design than the original windows.

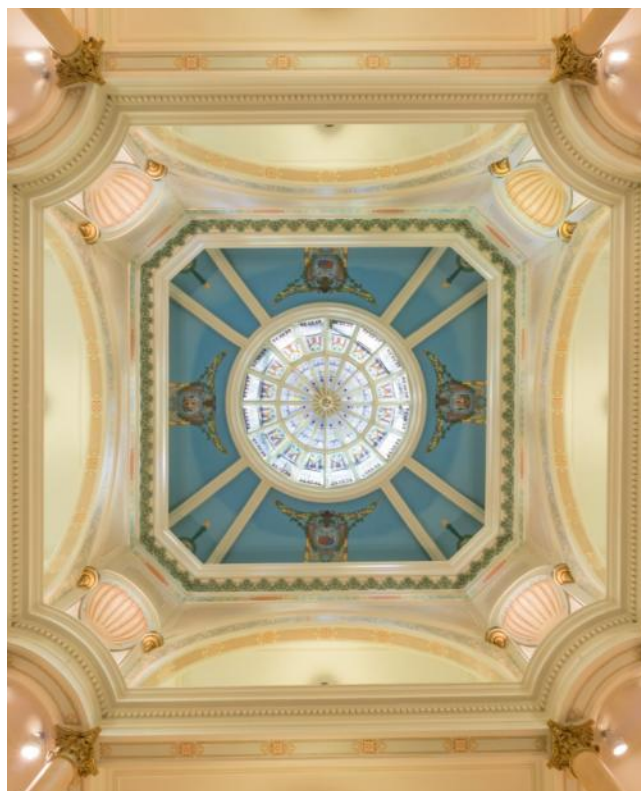
Figure 28.2: 1974-1980 Paint Scheme, 2013.

The selection of finishes was not based on historic research and factual evidence, and was done in violation of the accepted best practices and standards of the field of historic preservation.

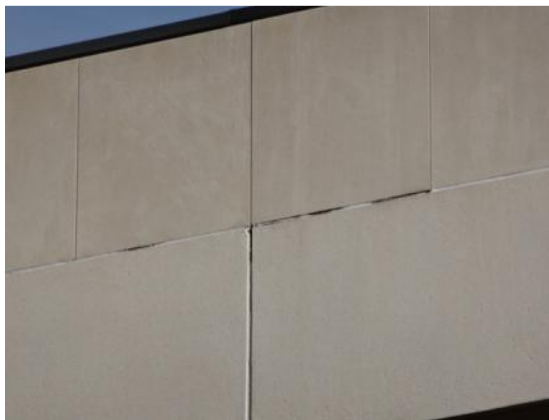
Several areas on the exterior of the building indicate a dis-coloration of the limestone and precast cladding indicating a presence of moisture. An in depth investigation is required to confirm this issue by utilizing a series of non-destructive probes to penetrate the exterior wall system for visual confirmation of the design team's concerns.

View of Existing North Herschler Façade

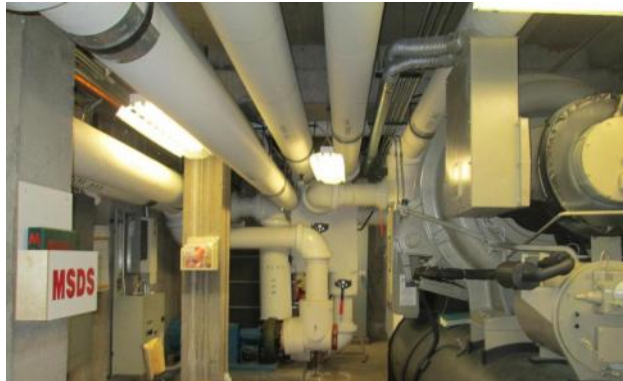
The distribution and most plant equipment are well maintained, in very good condition, and within their life expectancy (Mechanical and Electrical). The new Central Utility Plant (CUP) involves accommodating the expanded needs of the Capitol and Herschler. The best placement of the new CUP is being finalized. The security of systems is an additional component being explored and considered.

View of Existing MEP Systems at Underground CUP
